NDE OF CORROSION AND DISBONDING ON AIRCRAFT USING THERMAL WAVE IMAGING

Xiaoyan Han, L.D. Favro, Tasdiq Ahmed, Zhong Ouyang, Li Wang,
Xun Wang, P.K. Kuo and R.L. Thomas

Department of Physics and Institute for Manufacturing Research
Wayne State University, Detroit, MI 48202, USA

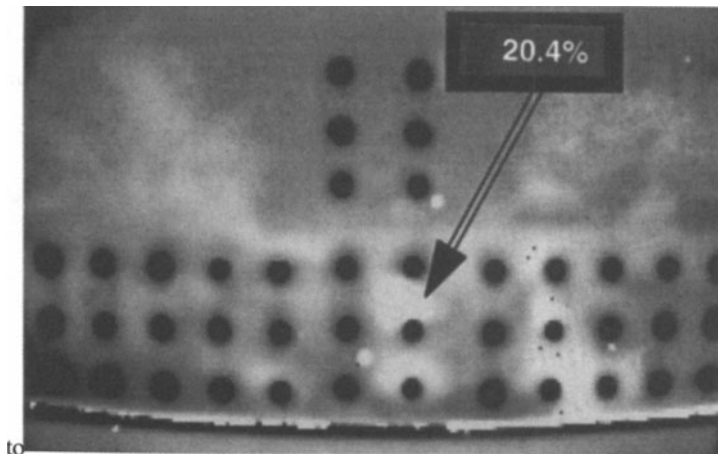
One of the test objects in the AANC "library" is a Boeing 737 testbed, which is available for use in developing NDI methodologies. In Fig. 2 we show a thermal wave image from a region of lap splice on this testbed - a target which is rather more complicated than the single fuselage skin just above it. The number (20.4%) which appears in Fig. 2 is the result of applying the quantitative corrosion thinning algorithm [2] to the bright region indicated by the arrow. Because of the presence of the fasteners (heat sinks - black) and the second layer of metal involved in the lap splice construction, it is not clear that this algorithm should work without applying some correction factors relative to the situation for a region of single fuselage skin. Nevertheless, following our measurement, shown in Fig. 2, one of the AANC staff members utilized a standard eddy current corrosion thinning measurement instrument and indicated that the corrosion was approximately 20%. Although laboratory studies are still in progress, we find that the thermal wave estimates in such situations are likely to be somewhat less than the actually corrosion thinning, and somewhat dependent on the lateral size of the region of corrosion, and the thickness of the layer of paint on the outside of the aircraft (unless it is very small compared to the skin thickness).

Fig. 2 Thermal wave image of a region of corroded (about 20%) lapsplice on the B737 testbed aircraft in the FAA's Aging Aircraft NDI Validation Center (AANC). The estimate (20.4%) is obtained from the thermal wave imaging corrosion analysis algorithm, known to be accurate for single skins [1], but likely to underestimate the corrosion for small lateral sizes of corrosion and for regions with thick paint.

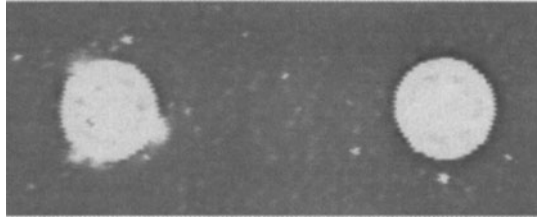
A second example of aircraft corrosion is illustrated in Fig. 3, which shows a single thermal wave image of two adjacent steel fasteners in a wing skin sectioned from an Air Force KC-135 aircraft. Because of the contact between the dissimilar metals (Steel/Al), the interface region in the countersink surface of the aluminum wing skin is susceptible to pitting corrosion, which in some cases, progresses laterally out from the countersink in the form of intergranular corrosion cracking. In a test program conducted by ARINC for the USAF, we have applied thermal wave imaging to 80 such fasteners in both KC-135 and B-52 wing skins. We succeeded in identifying 87.5% of the fasteners with confirmed intergranular corrosion (some of it quite minor, as seen in the metallographic optical imaging sections following the test), with zero false calls. In Fig. 3, two thermal wave images from this test are displayed, the left showing corrosion, the right showing uncorroded material.

Fig. 3 Thermal wave image of two adjacent steel fasteners in a wing skin sectioned from an Air Force KC-135 aircraft. The left fastener shows several regions of intergranular corrosion, extending laterally from the top of the fastener head which "shadows" the corrosion. The indistinct nature of the thermal wave reflections from the lateral subsurface corrosion is typical of the thermal blurring expected from subsurface defect scattering.

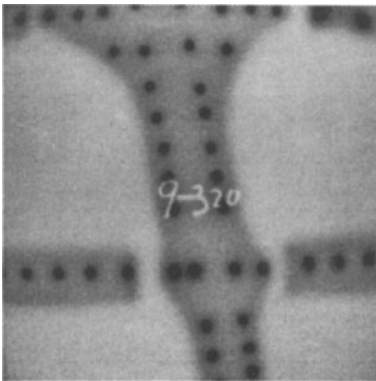
Fig. 4 (a) Thermal wave image of a well-bonded region of subsurface doubler from Section 41 of a B747 aircraft.

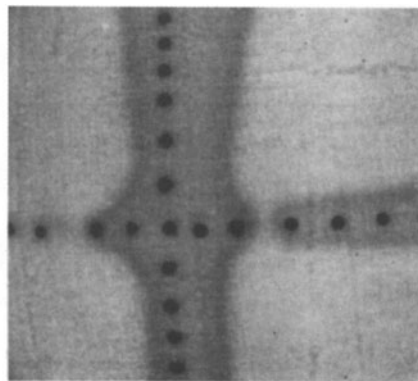
Fig. 4 (b) Thermal wave image of a disbanded region (left/center of the image) of subsurface doubler from Section 41 of another B747 aircraft.

from the airline and the manufacturer. The two methods agreed throughout the tests with one exception. One region, initially found to be disbanded by traditional testing, seemed well bonded thermally. Re-inspection by the manufacturer/airline confirmed the conclusion of the thermal wave imaging inspection.
